**PRE-CERCLIS SCREENING ASSESSMENT CHECKLIST/DECISION FORM**

<b>Eckel Site Name/Number</b>	Kramer, H. & Co. - 438
<b>Previous Names (if any)</b>	Allens Excavating, Chapkis Andrew B CPA, M&W Packaging Services
<b>Site Location</b>	631 S. Aviation Blvd., El Segundo CA 90245 1 Chapman Way. El Segundo CA 90245
<b>Latitude/Longitude</b>	33°54'28.66"N 118°23'11.59"W

<b>Project Name:</b> Lead Smelter Discovery		<b>Site Location:</b> Kramer, H. & Co. 1 Chapman Way, El Segundo CA	<b>Project No.</b> 20074.063.054.1001
<b>Photo No.</b> <b>1</b>	<b>Date:</b> May 24, 2012

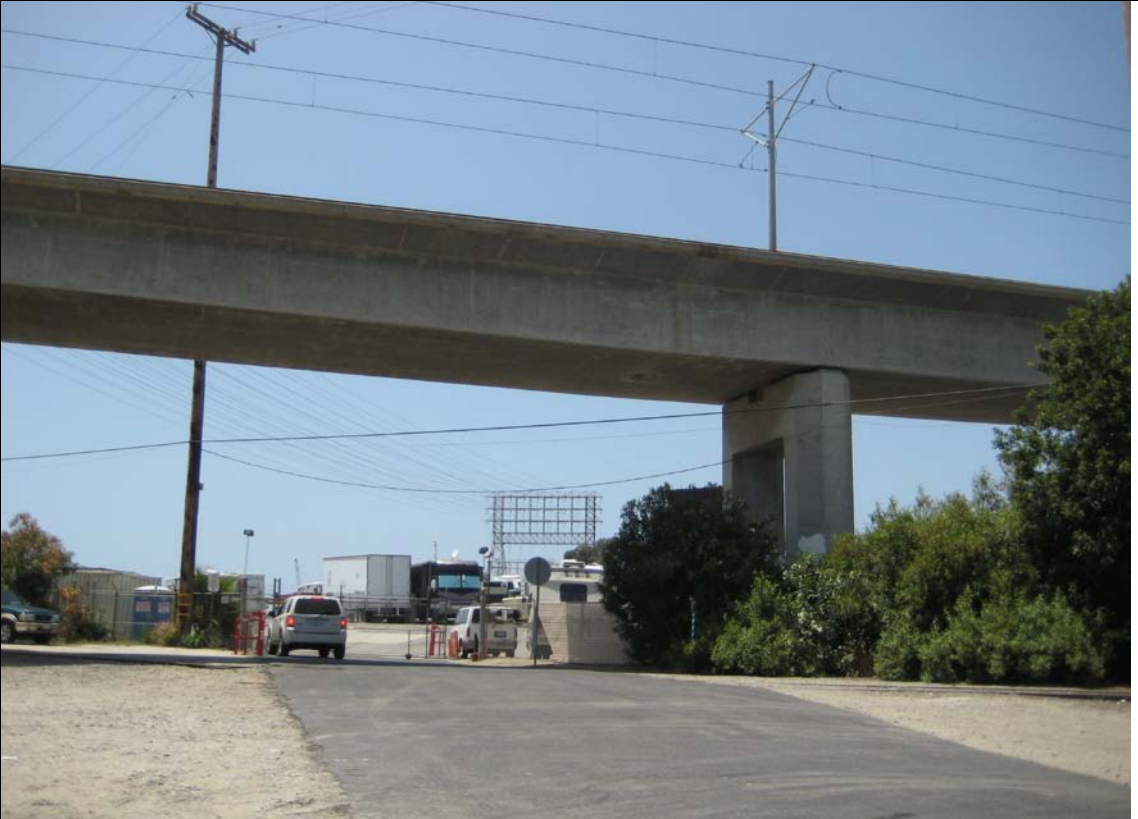
<b>Direction Photo Taken:</b> West			
<b>Description:</b> Photo showing the gated entrance to 1 Chapman Way and truck and RV storage beyond. The Metro Green Line is seen above.
